Technical investigation of an inshore accident with a twin crane lift arrangement from two barges.

Ir. Herm Bussemaker, MSc Naval Architect, Orca Offshore b.v., The Netherlands

PUBLISHED: 6 July 2016

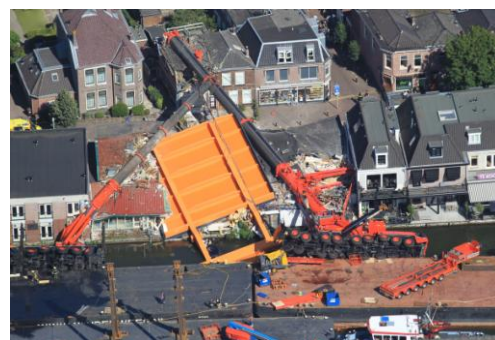
The two barges with the cranes were moored against the barge with the bridge fly. To pick-up the lift it was required to apply pretension with the crane and to ballast the barges to keep them on even keel. This operation took several hours. After lifting the bridge fly free from the supports, the crane operators started a slow inward move. At that moment the two barges developed a large list and the control over the system was lost which eventually

led to a progressive collapse and a complete fall over of the two cranes.

Figure 1 Situation after the accident (Source OVV)

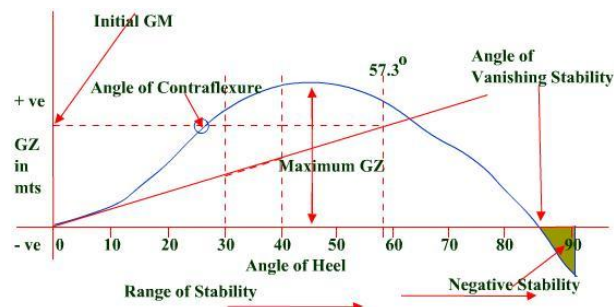
The stability at the equilibrium position has been evaluated using the GMt value which represents the transfers initial metacentric height of the barge. The GMt should normally be positive with an adequate margin for inaccuracies. Figure 2 shows a typical stability curve of a barge or ship. This plot represents the righting capacity of the barge as function of the heel angle. The initial GMt value is also indicated in this graph. A GMt value of zero or less represent an unstable condition of the barge which will lead to a large list towards a new equilibrium position with a positive GMt value. Figure 3 presents an example stability curve representing a negative GMt value at the evenkeel (heel=0°) situation of the ship. The stability curve shows a new equilibrium position at a heel angle of 30°.

Figure 2 Example Stability curve (Source: www.shipinspection.eu)

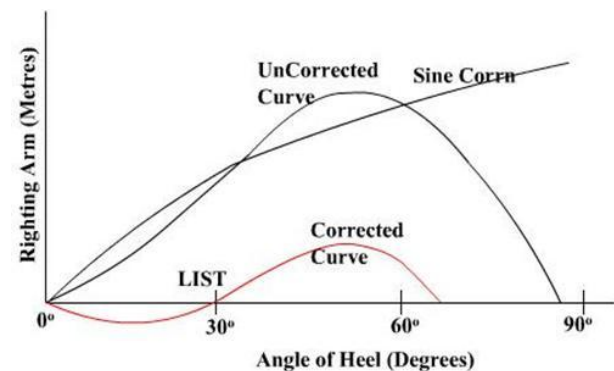
Figure 3 Example Stability curve (Source: www.shipinspection.eu)

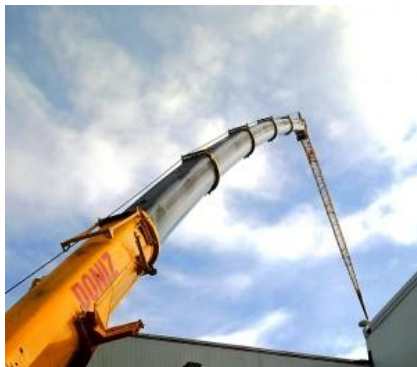
The general consensus to calculate stability of a crane barge combination is to assume that the lift load acts in the upper connection point of the lift arrangement generally referred to as the crane tip. This assumption is valid if the crane is infinitely stiff in all directions. Marine and offshore cranes are designed to accommodate a large side load which results in relative large stiffness in the side direction. Land based cranes are in general not designed for large side load which results in a lot lower horizontal stiffness of the crane.

Figure 4 Example crane bending (Source: www.Craneblogger.com)

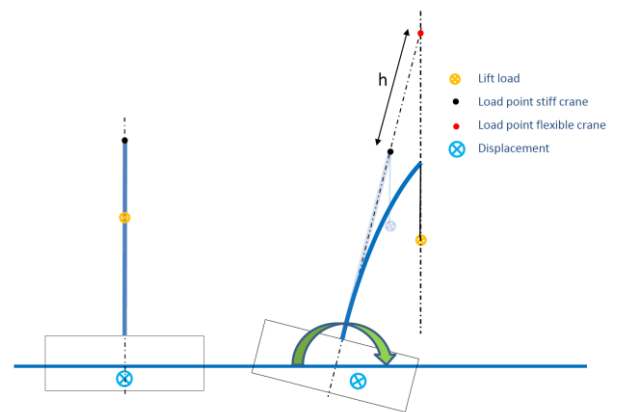
Figure 5 Diagram showing effect of flexible crane

Figure 5 shows a diagram explaining this effect. The diagram shows the deformation of the blue crane boom at a certain barge heel angle. As can be seen, the lift load attachment point has shifted due to the deflection of the boom. The lift load vector now crosses the crane centre line at the red dot which is at h meters above the black dot representing the lift load attachment point for an infinite stiff crane.

A simple formula has been derived which relates the vertical offset of the virtual lift attachment point from the crane tip to the crane tip stiffness as follows:

$$h = HL/k$$

with: h = vertical shift of centre of load (m)
 HL = Hookload (kN)
 k = Crane tip stiffness (kN/m)

The stiffness of one of the telescopic mobile cranes has been calculated by the manufacturer and made available for this investigation. Based in this number the vertical shift for the subject lift showed a vertical shift of the lift attachment point of 12 meter while the height above the barge deck of the crane tip was around 36 m. This resulted in significant GMt reduction. Table 3 presents the calculated GMt reduction for both barges and a summary of the GMt.

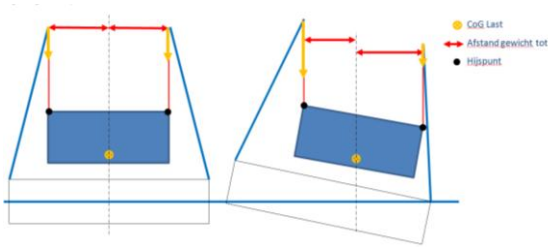
Using two cranes from one or more barges can have an effect on the stability of the barge(s). The hookload division between the two cranes can change as function of the heel angle of the barge and tilt of the load. With a single crane lift this does not occur. This change of hookload relates to the geometry of the lift arrangement and the lift centre of gravity position. Figure 6 shows an example of this effect which actually increases the stability of the barge. The heeled barge on the right of the diagram shows that the hookload has to change to maintain equilibrium of the lift. The hookload of the "down" crane decreases which has a stabilising effect on the barge.

Figure 6 Twin crane effect high lift points

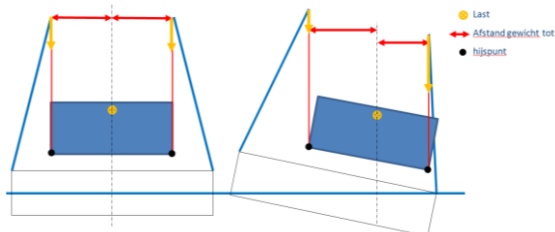
Figure 7 shows an example of this effect which has a negative effect on the stability of the barge. In this case the hookload of the "down" crane increases which has a de-stabilising effect on the barge.

Figure 7 Twin crane effect low lift points

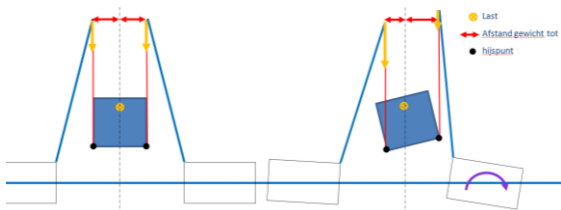
Figure 8 shows an example of this effect with two barges. In this case the hookload of the "down" crane increases which has a de-stabilising effect on both barges.

Figure 8 Twin crane effect from two barges

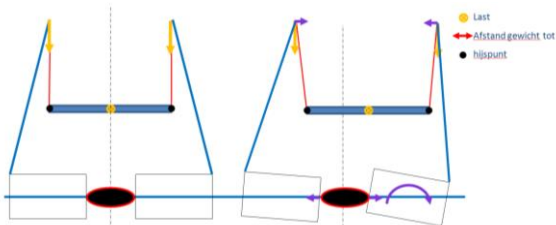
In case the barges are moored in any way to each other, a horizontal load at the crane tip can be developed. Figure 9 shows this effect which has a stabilising effect on both barges. It is however a risky situation as the fendering or mooring can suddenly slip or change which could initiate a sudden heel of the barges.

Figure 9 Twin crane effect moored barges

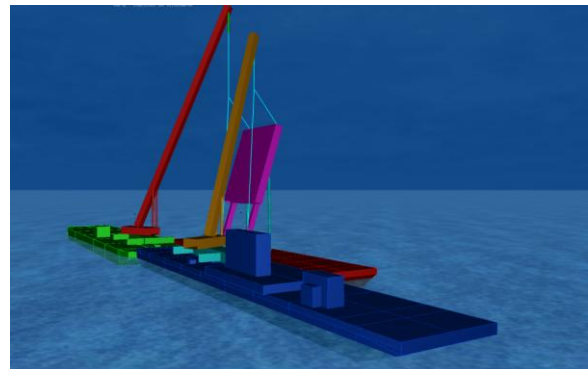
Figure 10 MOSES simulation model for twin lift effects

Figure 10 shows the model used for this analysis. The simulation based on the properties of the subject lift showed that in this case the twin crane stability effect was limited.

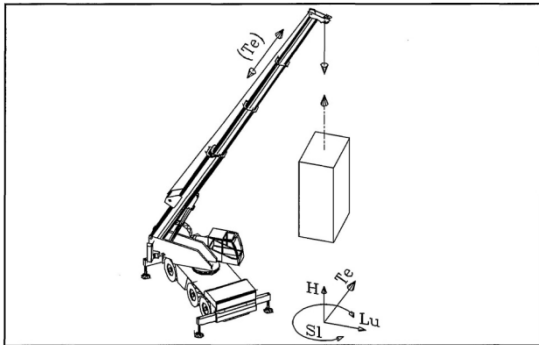
Crane actions are described in the case of a telescopic crane the load is moved by hoisting (H), slewing (SI), luffing (Lu) and telescoping (Te), see Figure 11.

Figure 11 Definition of crane movements (Source: BS EN 13000:2004)

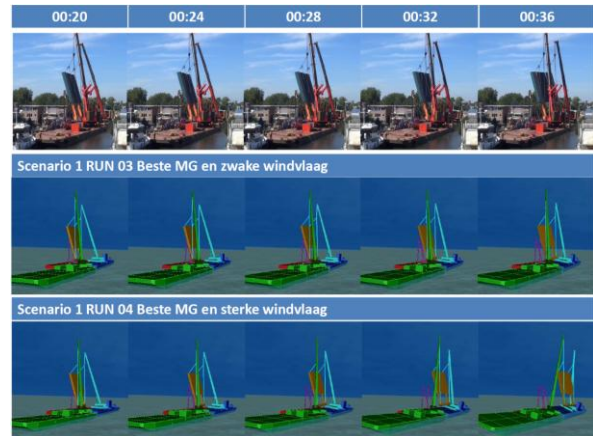
Figure 12 Simulation for wind gust with best estimate GMt values

Figure 12 shows some frames of the video taken from the incident and corresponding frames of the simulation.

The performed simulation showed good correlation with the reality as recorded with the video, also confirming the low stability as root cause of the incident.
