Skand Pty. Ltd.

# Skand Delivers Integrated 3D Model and Asset Lifecycle Program for a University Campus

ContextCapture Sped-up the Project Four Times Faster, Saving AUD 70,000

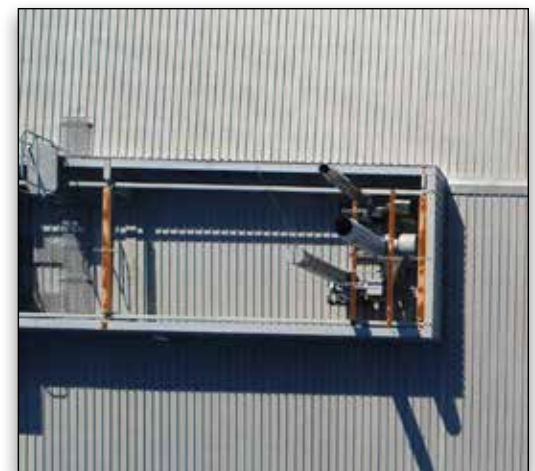
Skand projects AI-identified defects onto the ContextCapture reality mesh including forms of corrosion and building material degradation.

Using artificial intelligence (AI), Skand can identify and categorize defects when analyzing the 2D images and then project these defects onto the 3D reality mesh. ContextCapture helped the project team create 16 categories of defects on both the roofs and facades, including cracks, moss, algae, rust, and other forms of corrosion and building material degradation. Skand’s web application displays the ContextCapture 3D reality mesh with the detected defects mapped out, creating an inspection and condition report powered by Power BI.
