Type of Site
Tailings Dam

Location
South America

Tailings Dam Owner-Operator Generates 3D Model to Analyze Slope Stability at Mine Site

SVSLOPE[®] Software Analyzes Cross-Sections of Soil for Safety Factor

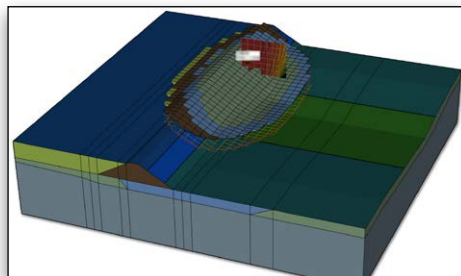
Tailings dam after critical slip found.

SVSLOPE[®]3D was used to conduct a 3D slope stability analysis. The data associated with the pre-existing cross-sections of soil were input into the software to generate a 3D model. Within this application, the materials and groundwater levels transitioned from 2D conditions to 3D conditions automatically. This analysis indicated a shallower failure surface and a higher safety factor because of the inclusion of the coarse, granular soil that is situated on the valley sides.

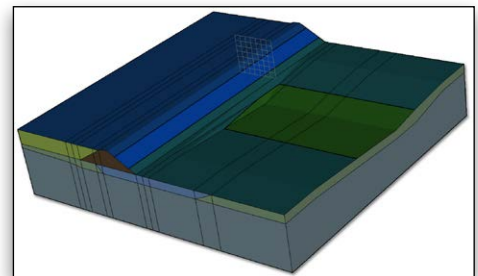
Tailings dam pre-analysis.

The owners of the tailings dam used SVSLOPE[®]2D to analyze three cross-sections of the embankment, each of which represented various foundation conditions along the embankment. The lowest 2D safety factor was calculated in the cross-section that included the soft soil material, where a deep failure surface was discovered. This failure, which was defined as critical, was due to the soft, clay deposits within the soil. However, this designation did not take into account the surrounding coarse alluvial materials and the 3D effects that were
